City of Ava Stormwater Infrastructure

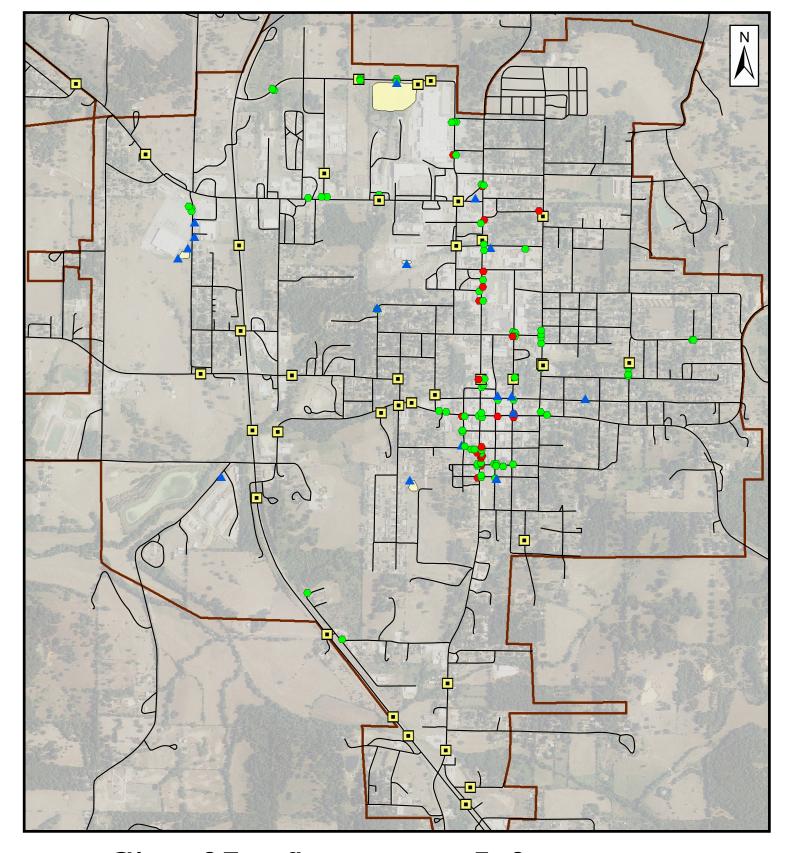
- Box Culvert
- Inlet, Poor Condition
